YOUR INSPECTION REPORT

FOR THE PROPERTY AT:
1234 Sample Inspection Rd.
Eureka, IL 61530

INSPECTION DATE:
Friday, July 12, 2019

Report No. 1001, v.2

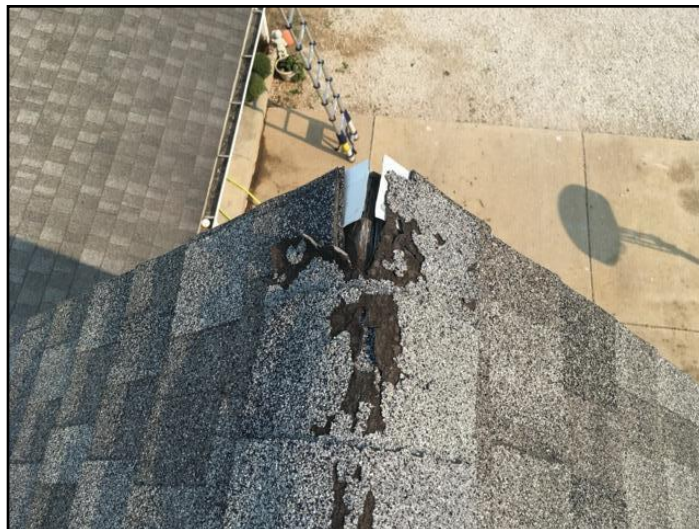
Condition: • [Near end of life expectancy](#)

Budget to replace entire roof within 5 years.

Implication(s): Chance of water damage to contents, finishes and/or structure

Deteriorated/damaged shingles on dormer ridge

Task: Inspect annually

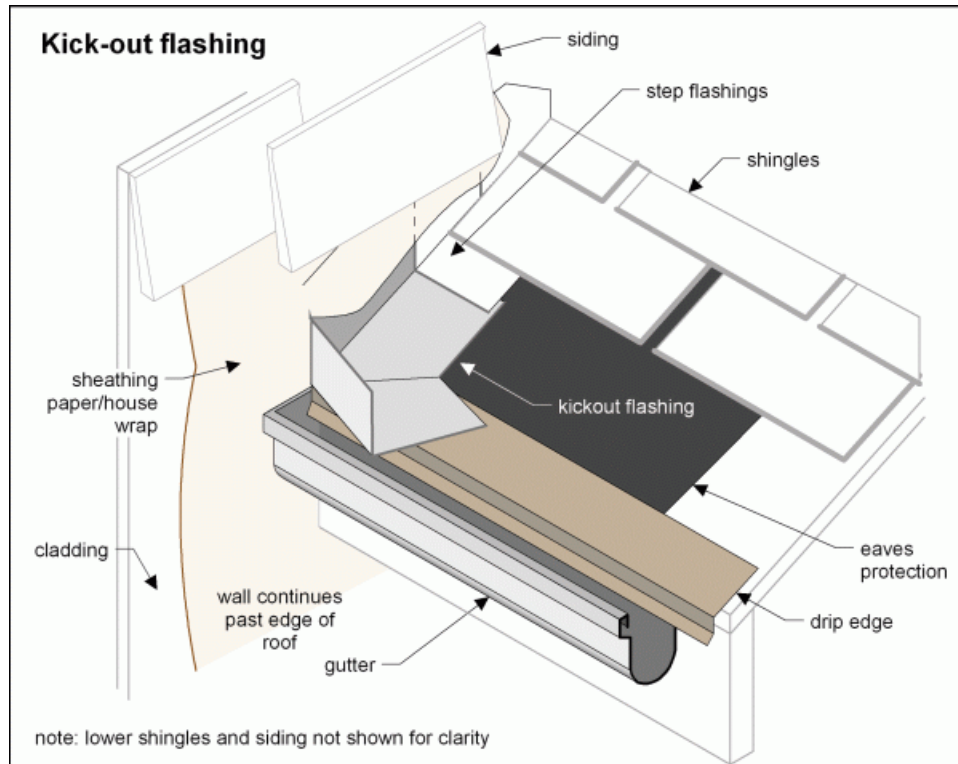
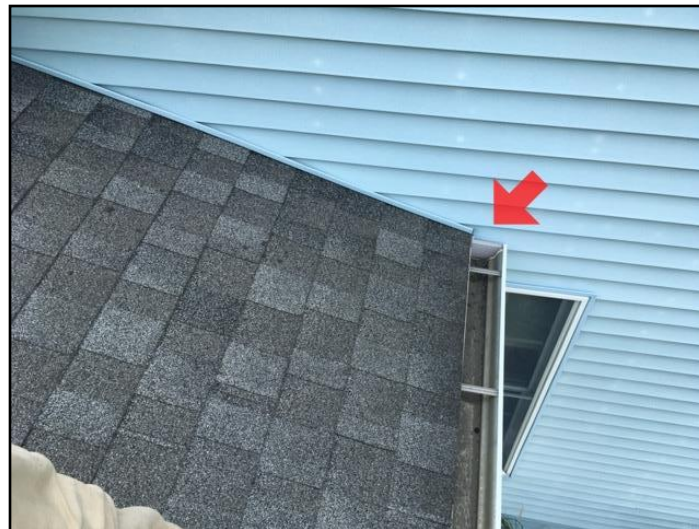
Condition: • [Kickout flashing - missing](#)

Implication(s): Chance of water damage to contents, finishes and/or structure

Location: North

Kickout flashing - missing

Task: Monitor

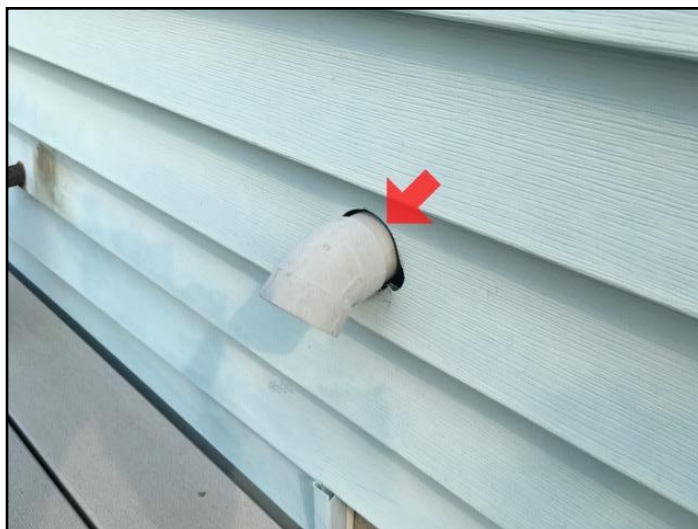
Condition: • [Caulking missing or ineffective](#)

Implication(s): Chance of water damage to contents, finishes and/or structure

Location: South Exterior Wall

Missing caulk around utility penetration

Task: Provide

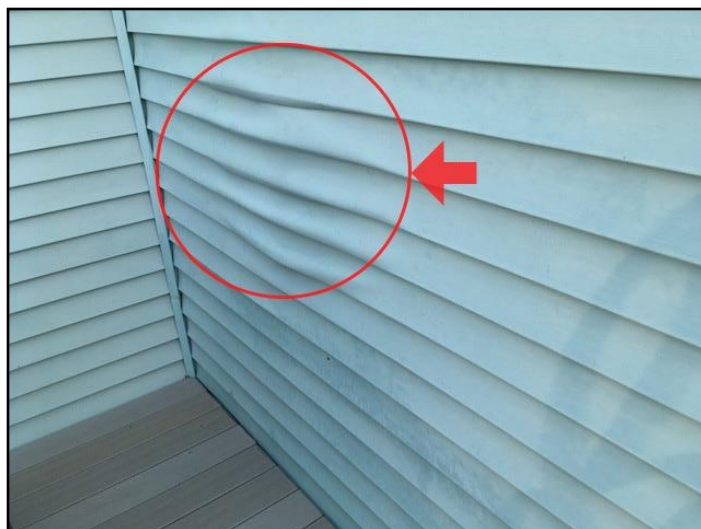
Condition: • [Buckled or wavy](#)

Location: South Deck

Deformed vinyl siding, from high temp - grill

Task: Replace

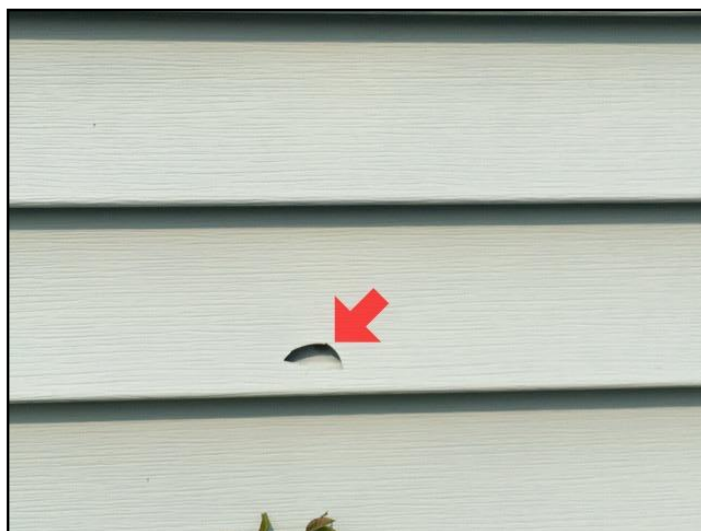
Condition: • Cracks/holes, loose or missing pieces

Implication(s): Chance of water damage to contents, finishes and/or structure

Location: Various sides of the home

Holes/cracks in vinyl siding

Task: Replace

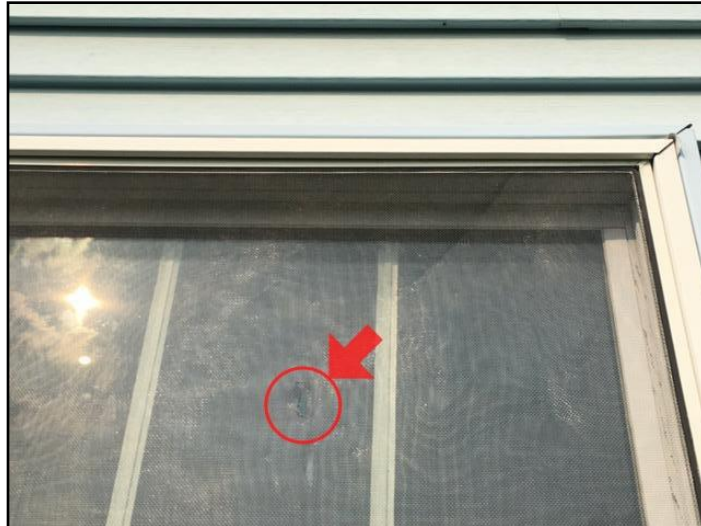
Condition: • [Torn or holes](#)

Implication(s): Chance of pests entering building

Location: Various windows around the house

Example of a screen with a hole

Task: Repair or replace

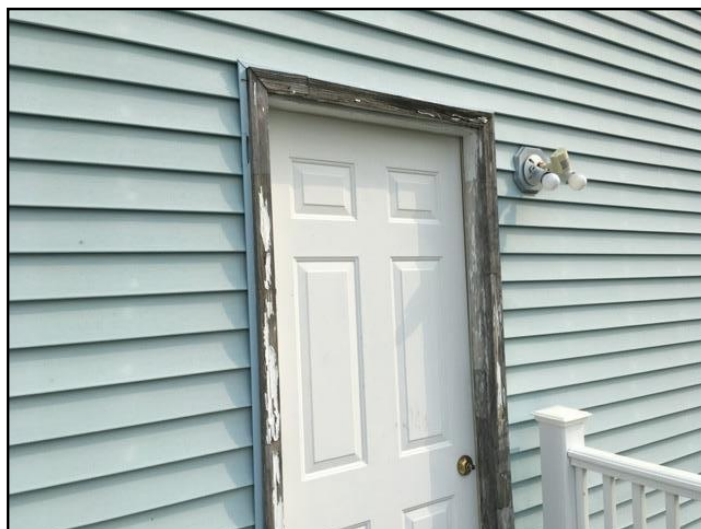
Condition: • [Paint or stain needed](#)

Implication(s): Chance of damage to finishes and structure | Material deterioration

Location: South Exterior Wall Garage

Paint needed on garage service door

Task: Provide paint or wrap with aluminum

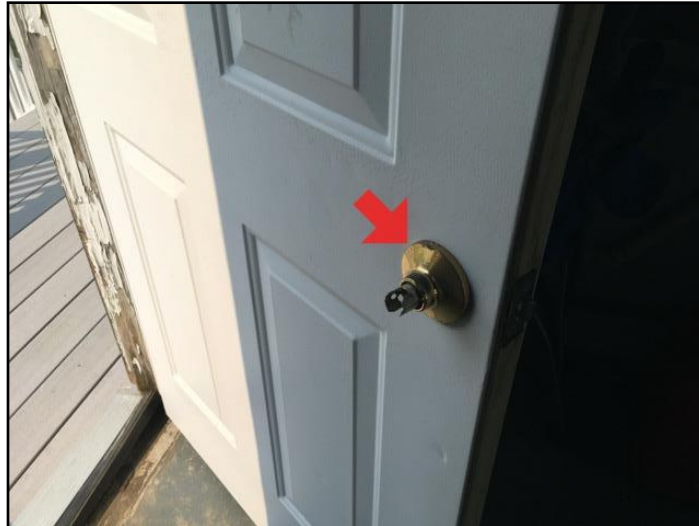
Condition: • Missing or damaged

Implication(s): Increased heating and cooling costs | Poor security

Location: South Exterior Wall

Missing door knob - inoperable from exterior

Task: Provide

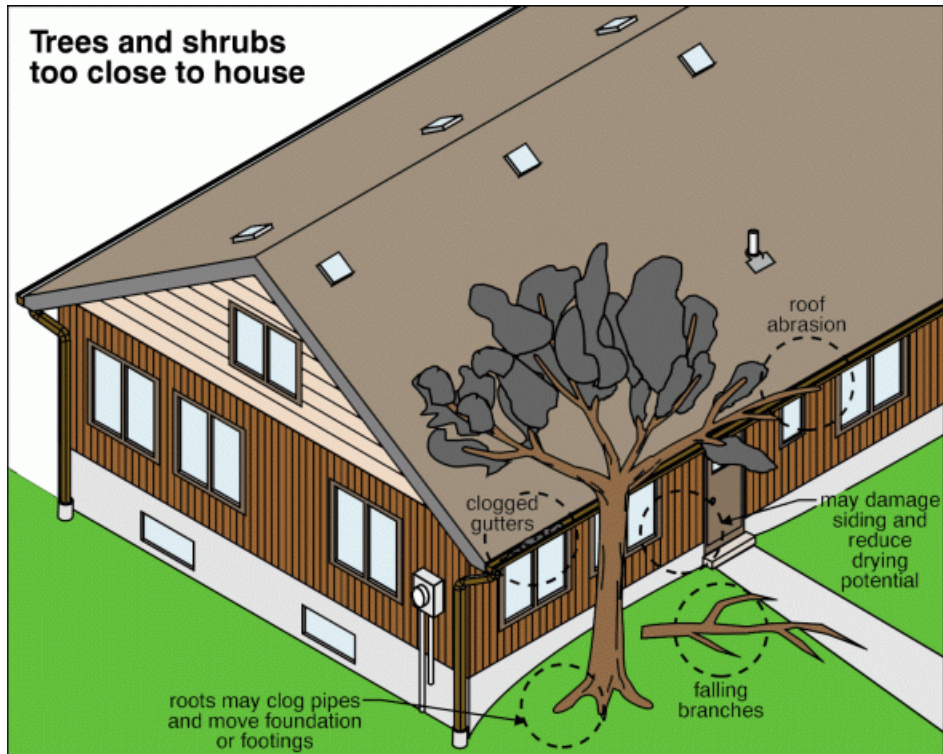
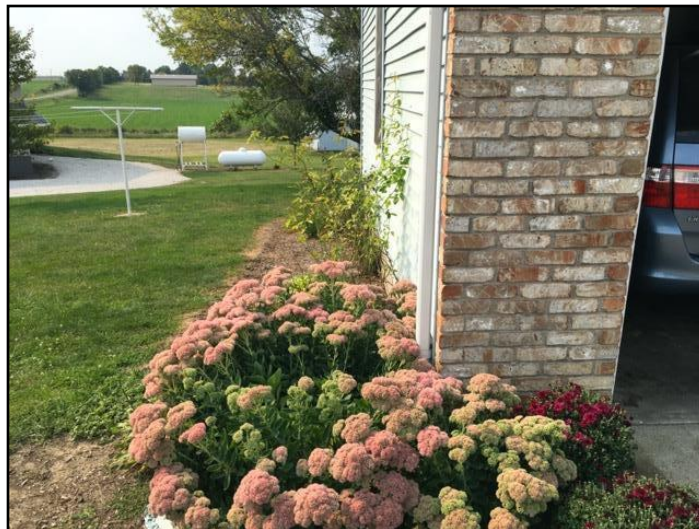
Condition: • [Trees or shrubs too close to building](#)

Implication(s): Chance of water damage to contents, finishes and/or structure | Chance of pests entering building | Material deterioration

Location: East Exterior Wall Garage

Vegetation/shrubs too close to building

Task: Clean

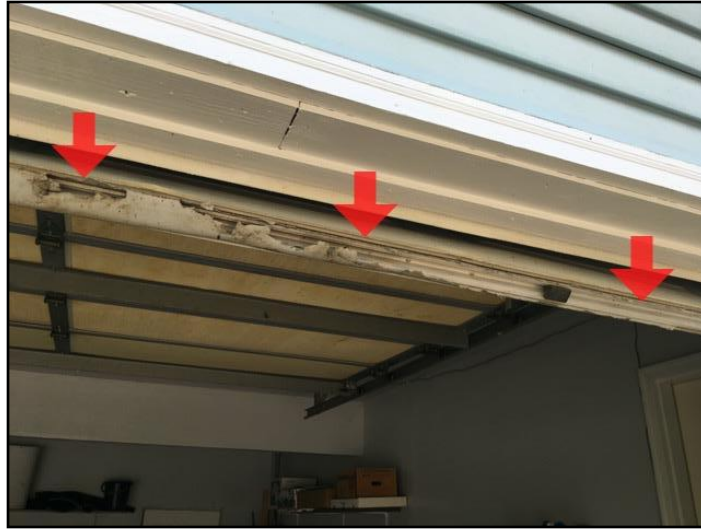
Condition: • Weatherstripping damaged or missing.

Location: North Exterior Wall

Weatherstripping damaged or missing.

Task: Replace

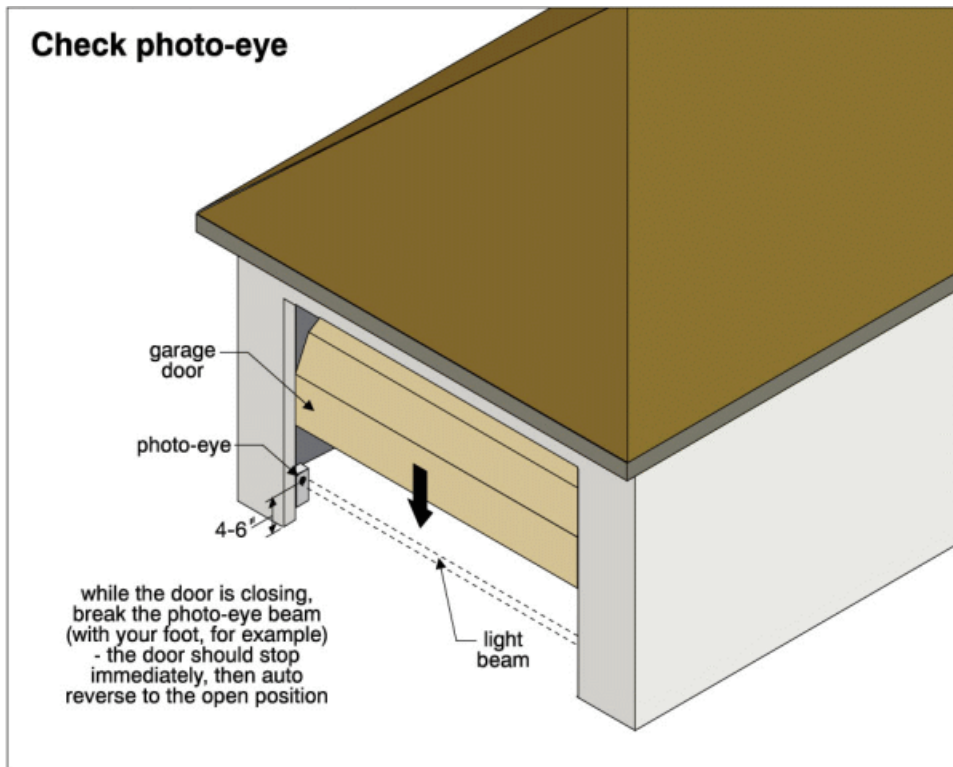
Condition: • [Sensors inoperative](#)

Implication(s): Physical injury

Task: Provide

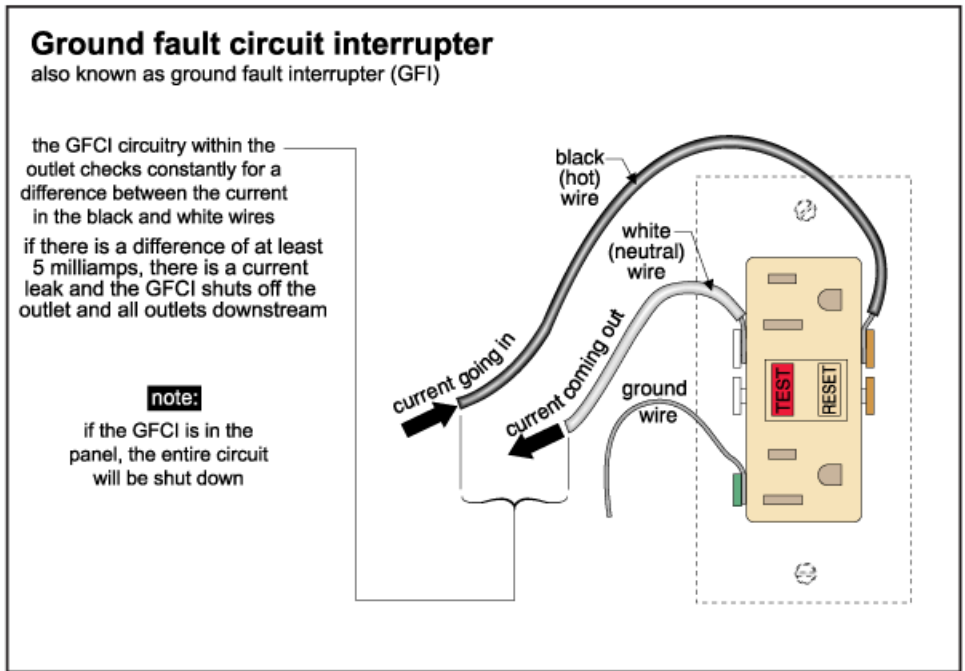
- DISTRIBUTION SYSTEM \ Outlets (receptacles)**
- Condition:** • [GFCI/GFI needed \(Ground Fault Circuit Interrupter\)](#)
- Implication(s):** Electric shock
- Location:** Exterior, Kitchen, and Garage
- Task:** Provide
- Time:** Less than 1 year
- Cost:** \$100 - \$300

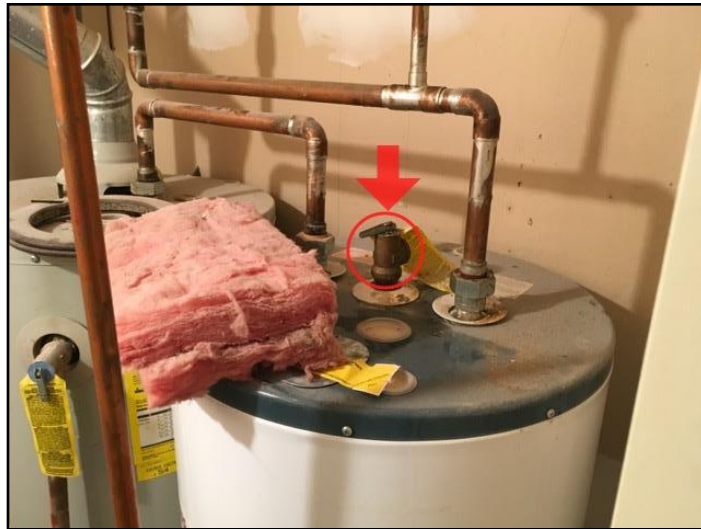
Condition: • [Discharge tube missing](#)

Implication(s): Scalding

Location: Basement Utility Room

Rheem water heater TPR valve ext. missing

Task: Provide

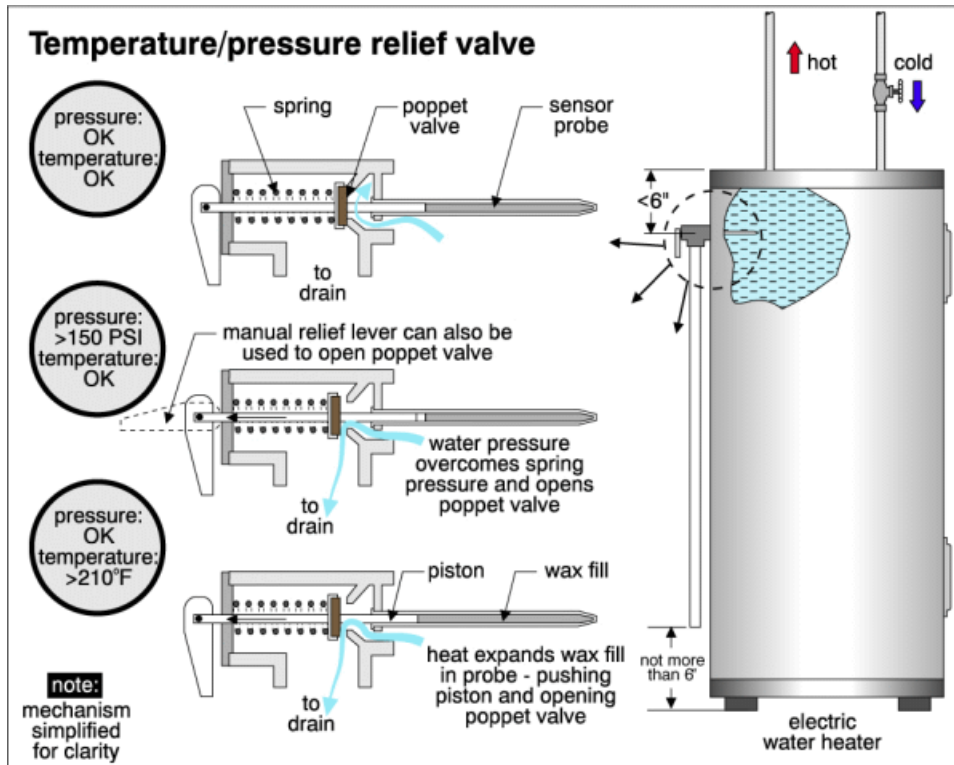
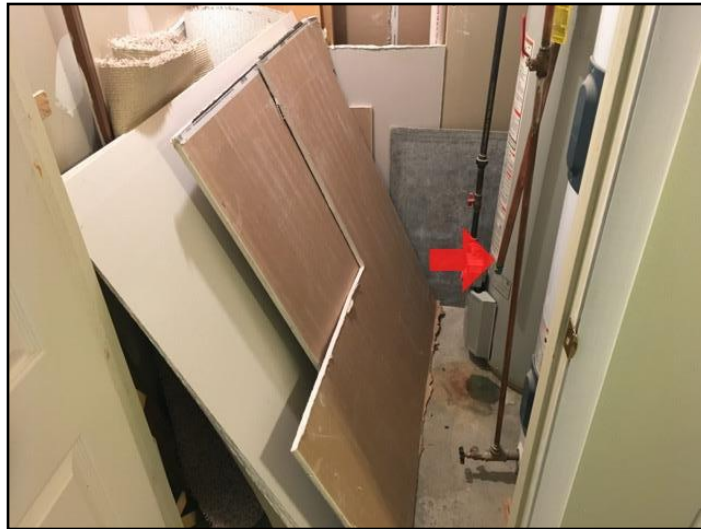
Condition: • [Discharge tube too short](#)

Implication(s): Scalding

Location: Basement Utility Room

State water heater TPR valve ext. too short

Task: Improve

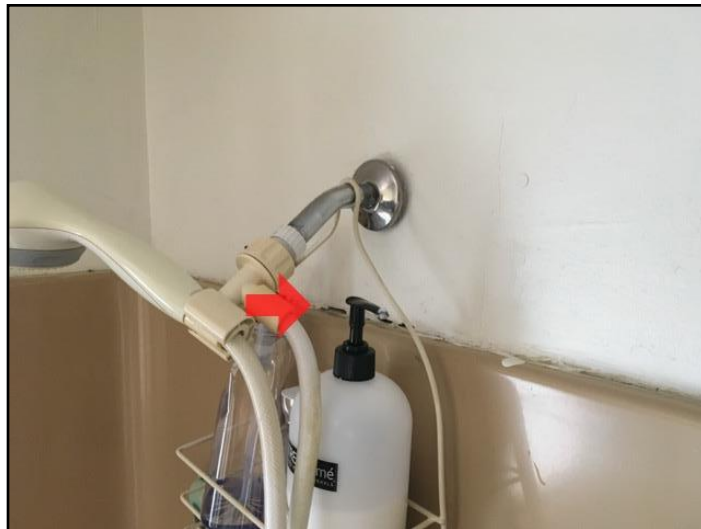
Condition: • [Caulking loose, missing or deteriorated](#)

Implication(s): Chance of water damage to contents, finishes and/or structure

Location: Master Bathroom

Caulking missing/deteriorated

Task: Repair

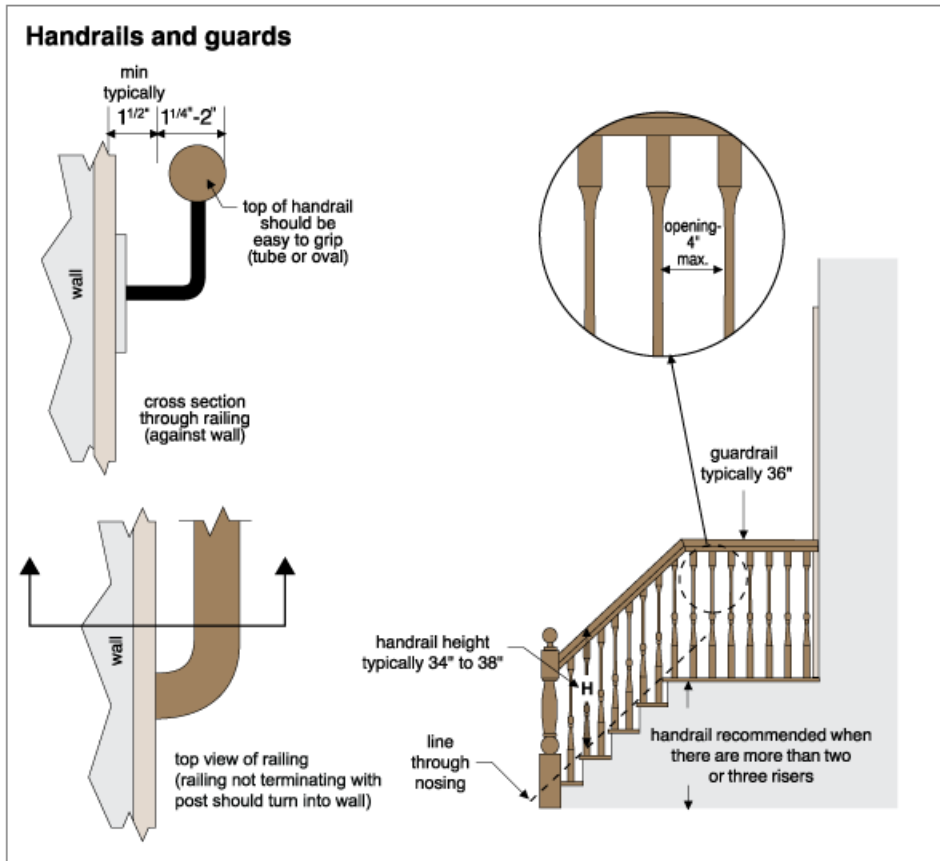
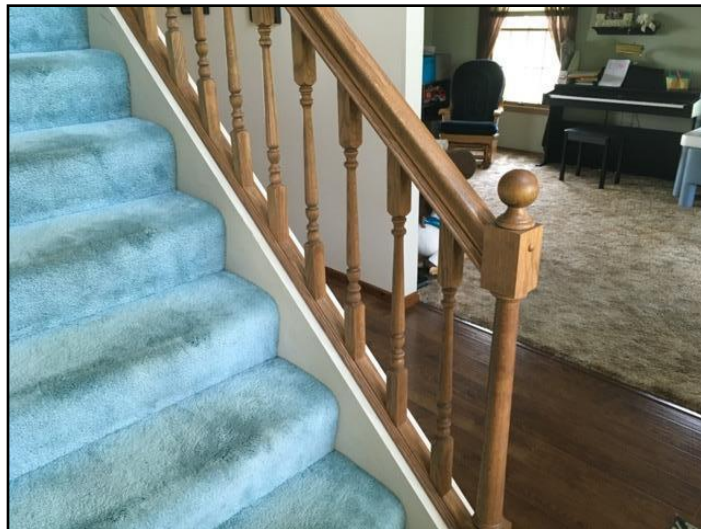
Condition: • [Too far apart](#)
(especially for small children)

Implication(s): Fall hazard

Location: First Floor Staircase

Balusters too far apart

Task: Correct

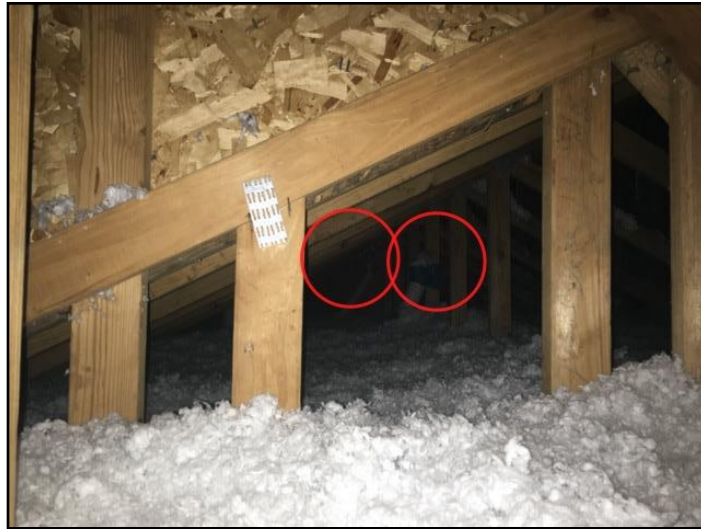
Condition: • [Not vented to exterior](#)

Implication(s): Chance of condensation damage to finishes and/or structure

Location: Attic

2 bath exhaust fans not vented to exterior

Task: Correct
